案内標識における一部不具合と今後の対応について

Lifting issue on certain road signs made with 3M sheeting

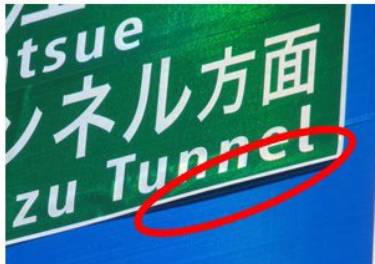
以下の2つの部位において反射シートの浮きが一部確認されております。

事象	多層重ね貼り部分（下地シートの上 に貼られる路線名等を示す箇所）	素地シート重ね貼り部分（下地シート同士 のつなぎ部の10mm程度の重なり箇所）
例

現在、道路管理者様が確認なされた剥離事象が発現した案内標識につきましては、弊社において実際に現地にて剥離事象を確認し、補修を進めております。補修作業にあたりましては、変性シリコン系化学反応型接着剤の塗布とエッジシールテープの貼付や案内標識の交換を行い、補修作業完了後は引き続き経緯観察を行ってまいります。補修作業の完了は、本年7月下旬を目途に鋭意進めております。

また、標識メーカー様にて作成中および今後新しく製作する案内標識につきましては、接着強度を増強するために、多層重ね貼り部分の下地および素地シート重ね貼り部分に対するサンディングとエッジシールテープの貼付を実施いただけるよう要請致しております。加えて、標識メーカー様等のご協力のもと作業手順の監査を実施するとともに、補修工事完了後は経過観察を行ってまいります。
