台風15号通過後の案内標識の一部不具合の事象確認について

<事象概要>

Delamination issue on a road sign made with 3M sheeting after Typhoon Faxai

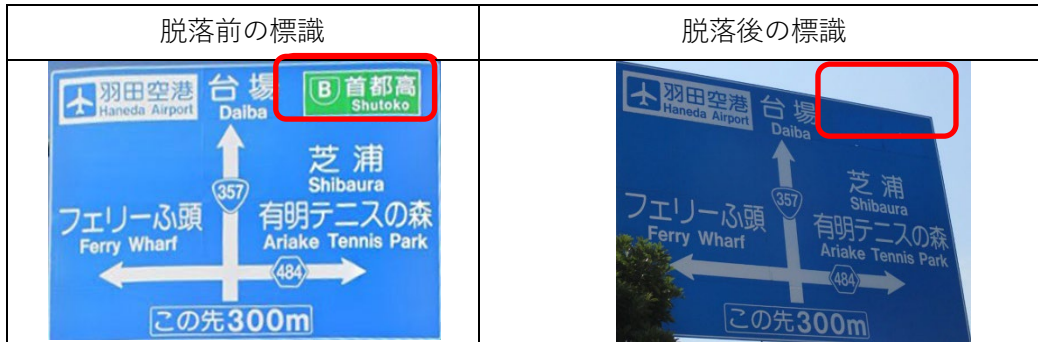
- ・事象： 道路案内標識の多層重ね貼りシートの剥離
- ・事象確認日： 9月9日
- ・事象発生箇所： 国道357号 東京都江東区有明2丁目交差点付近

剥離したシートおよび剥離後の標識板の表面状態を観察した結果、多層重ね貼り部端部に剥離があったと想定され、今回の台風での強風にあおられたことが主要因と考えられます。

2019年9月8日から9日にかけて関東地方を通過した台風15号の強風の影響により、当該シートは脱落したものと推定されます。なお、当該標識の設置場所は海岸に面した埋め立て人工島であること、また隣接する道路沿いには高層ビルが建っていることから、局所的に猛烈な強風が発生した可能性もあります。

多層重ね貼りに端部剥離が見られる標識は、端部剥離の状況から必要と判断される場合は、粘着テープ等を用いて緊急的に端部剥離部を元の板上に貼り戻す応急処置を行い、脱落を抑止します。

端部剥離事象が確認された場合は、状況に応じて応急補修を行い、かつ速やかに交換等の補修対応を行います。

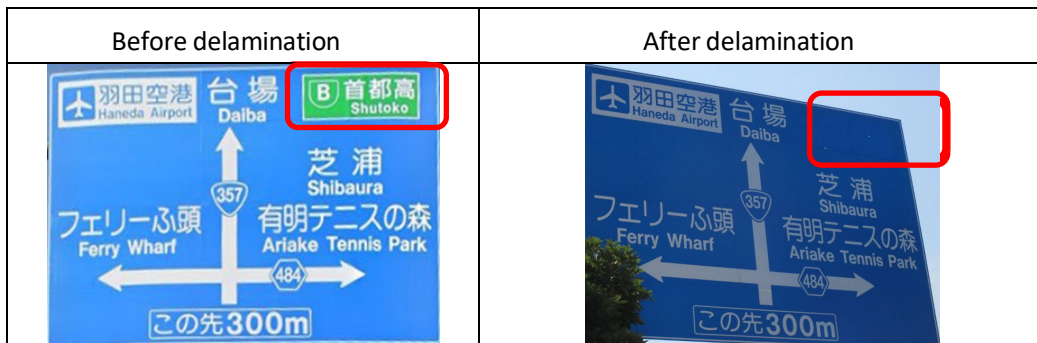
- Issue: Delamination of sheet on sheet part of guide sign
- Confirmed: September 9, 2019
- Location: Route 357, intersection of Ariake 2-chome, Koto-ku, Tokyo

The observation results for both the delaminated sheet on sheet piece and the surface of guide sign suggested that there had been edge liftings of that sheet on sheet piece. It is considered that the main factor of delamination is certain area of edge liftings flapped by very strong wind due to the typhoon Faxsai hit the Kanto region from Sep 8 to 9, 2019. Additionally, the location of the guide sign aside by buildings at bay area has a possibility of local violent wind.

For the sign which shows a certain area of edge lifting, to seal sheet on sheet piece with adhesive tape is effective as a first aid.

3M will keep continue monitoring scoped guide signs with regular reporting, and conduct repairs with necessary measures for the entire warranty period when 3M finds a sheet lifting.
